Effects of coal mining on the water resources in the communities hosting the Iva Valley and Okpara Coal Mines in Enugu State, Southeast Nigeria

**Sustainable Water Resources
Management**

Sustain. Water Resour. Manag. (2016)
2:207-216

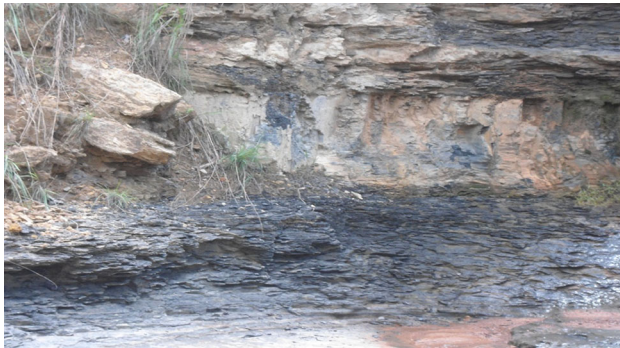
Fig. 3 A section of the Mamu Formation exposed at a river bank and from which the lithology in Fig. 2 was described

Fig. 2 Lithology of the Mamu Formation described from a river bank exposure close to the Iva Valley coal mines

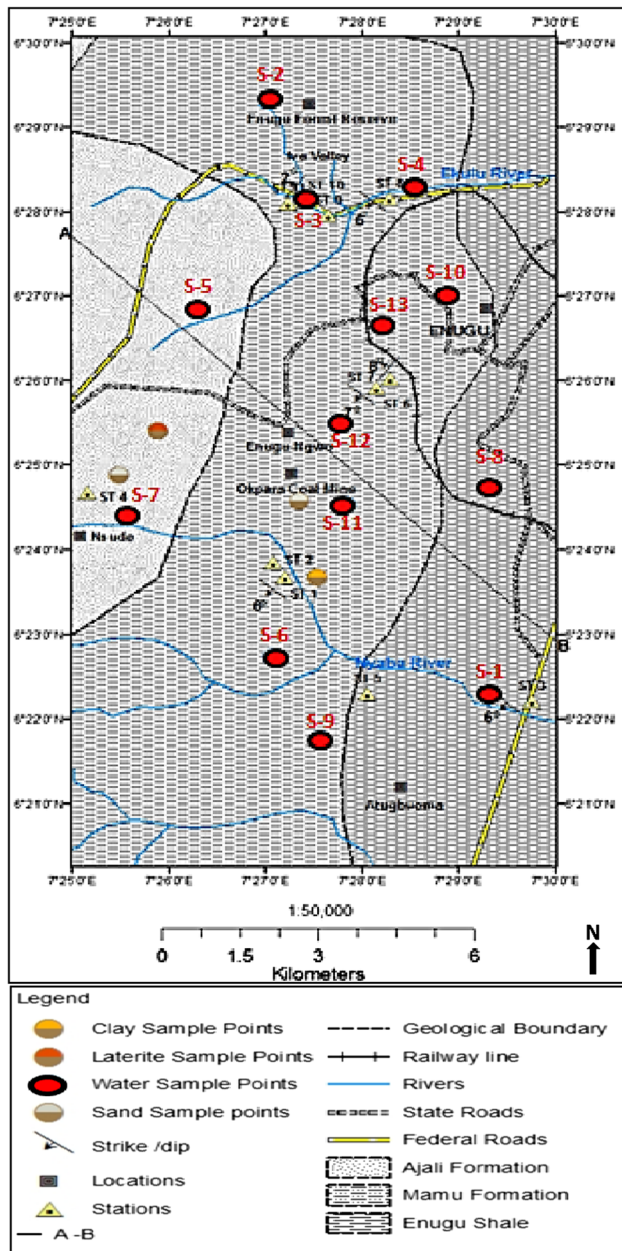
Fig. 4 Geologic map of study area showing the boundaries of the formations and the position of the water sampling points

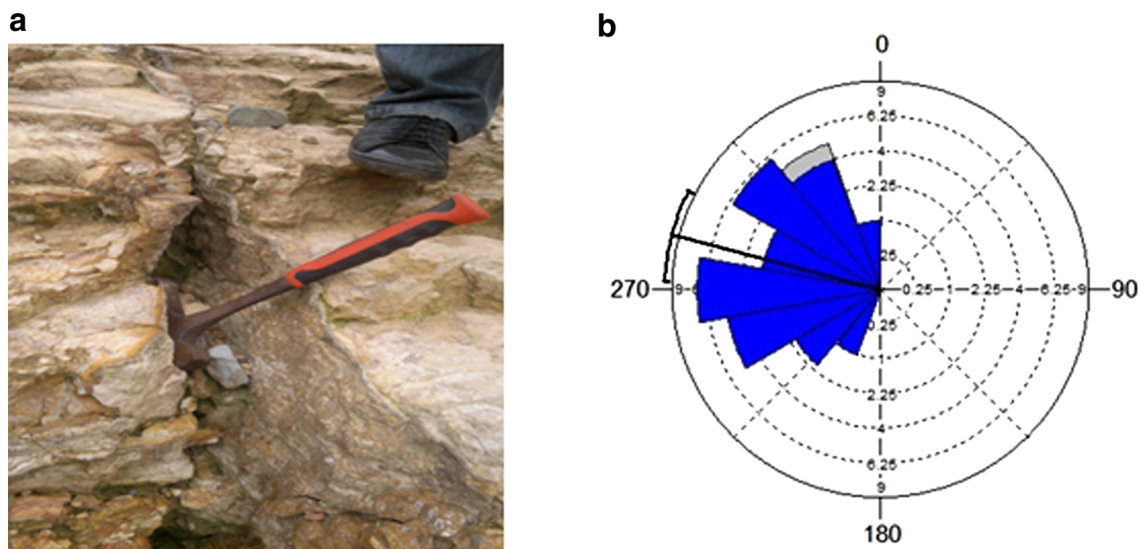
Fig. 5 Fracture in the outcrop of Mamu Formation (a) and rose diagram showing dominant fracture trend in the study area (b)

enhance the porosity and permeability of rocks; and also form ready conduit for fluid and contaminant transport especially when primary porosity and permeability are poor. Structural mapping showed that the rocks in the study area are fractured with the highest fracture density found in the units of the Mamu Formation. A careful study and analysis of the fractures show that the dominant trend of these fracture is in a more or less east–west direction, with some minor fractures in other orientations connecting the fractures in the dominant orientation (Fig. 5a).

surface water bodies. The aperture width of the fracture varies and is significant. Some of the fractures have been filled in by secondary materials. However, almost all the fractures observed show iron stains/precipitates, indicating that they are ready pathways for fluid transport. The dominant trend of the fracture is presented in the rose diagram below (Fig. 5b).

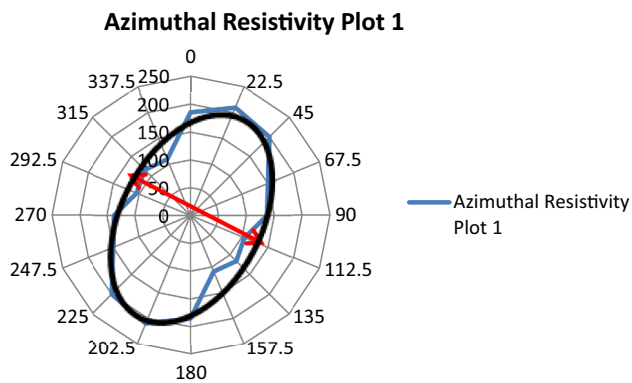
Fig. 6 Azimuthal polar plot fitted with an ellipse and an arrow indicating the dominant fracture (and possibly seepage pathway) trend orientation

Using the azimuthal square array resistivity survey method, the azimuth of existing fractures zones (and likely seepage pathway) is generally indicated by a decrease in resistivity along that particular azimuth relative to the others. Hence, plots of apparent resistivity values as a function of azimuth are used to characterize electrical anisotropy. Circular plots are characteristically interpreted to indicate electrical isotropy, suggesting the absence of measurable fracture set of preferred orientation, or small volume of rock investigated (Busby and Peart 1997). On the other hand, elliptical plots are generally construed to signify anisotropic response within the rock mass. With the square array, the orientation of the dominant fracture trend is defined and interpreted as the orientation of the minor axis of the ellipse fitted to the polar plot. Visual inspection of the ellipse fitted to the polar plots (Fig. 6) showed that the fracture trend is approximately NW–SE and this compares well with the fracture trend mapped at the surface (Fig. 6).

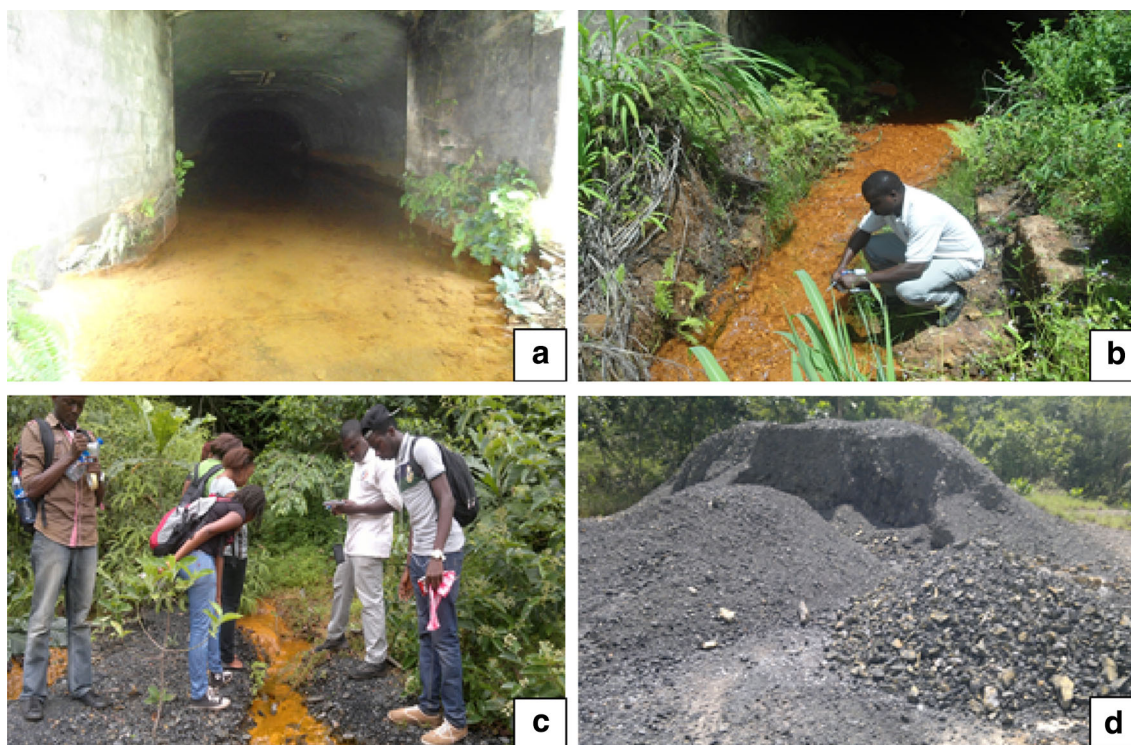
Fig. 7 Water flowing out of a mine tunnel which intercepts the water table at the Iva Valley coal mine (a, b) through and over surface mine waste dump site (c) scattered indiscriminately over the study area (d)

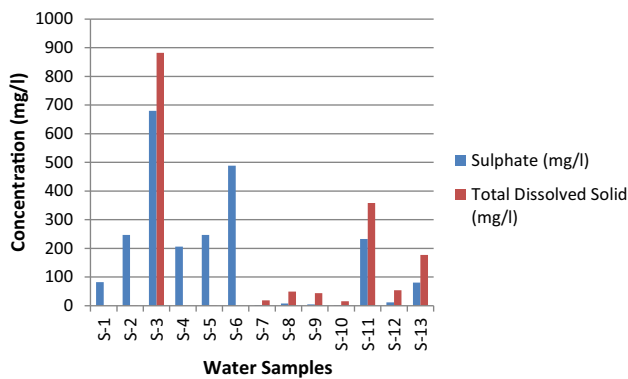
Fig. 8 Sulphate and total dissolved solids distribution in water samples of the study area

Two samples presented sulphate values high above the WHO standard: Sample S-3 with value of 680 mg/l and Sample S-6 with value of 488.1 mg/l (Table 1; Fig. 8). Sulphate ions are products of the oxidation of minerals such as pyrite which are found in association with coal in the Enugu area. High solubility of the sulphate ions makes it easily leached, and perhaps responsible for these high values recorded in the samples. High sulphate ion values in excess of 250 mg/l may have laxative effects (Ezeigbo and Ezeanyim 1993).

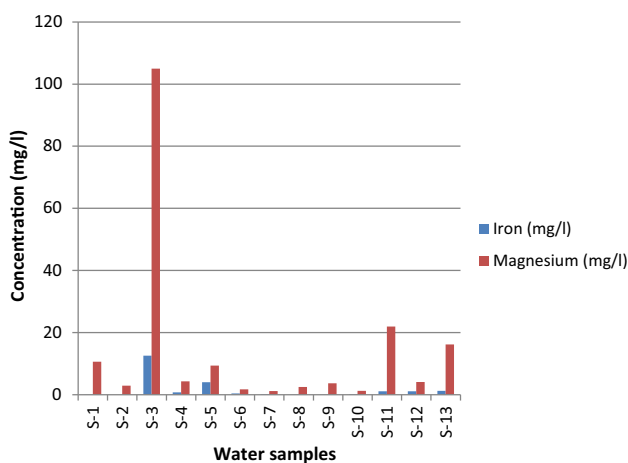
Fig. 9 Distribution of iron and magnesium in water samples of the study area

Seven (7) samples presented values significantly above the WHO permissible limits for iron while four (4) samples

have values for manganese above WHO standard (Table 1; Fig. 9). Iron is a common component of coal mine drainage which can have a detrimental effect on human, animals and aquatic life as well as reduces the suitability of contaminated water for domestic, agricultural and industrial uses (Earle and Callaghan 1998). The high iron value may be largely due to the presence of abundant pyrite in the coals and rocks of the study area. Manganese is another metal that is widely distributed in mine drainage. Manganese can be present in a variety of forms and compounds, and complexes with organic compounds. Neurological disorder is one of the negative health implications of high manganese concentration in water consumed by humans.

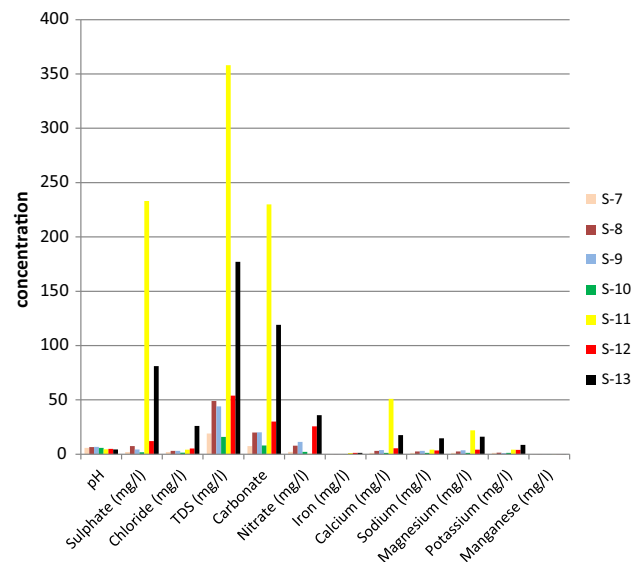
Fig. 10 Distribution of some geochemical species in borehole (S-7 to S-10) and shallow well (S-11 to S-13) water samples in the study area

All the surface water samples (Samples 1–6 in Table 1) have low pH well below WHO limits. This is also the case for shallow well water samples (Samples 11–13 in Table 1); while only two borehole water samples presented low pH. All the borehole samples (Samples 7–10) gave iron values which are within the WHO limits while all the shallow wells and majority of the surface water samples presented values outside and above the WHO limits. Manganese is found to be in concentrations well above the WHO limits in all but two (2) of the surface water samples while all the groundwater samples presented values below and within the WHO permissible limits.

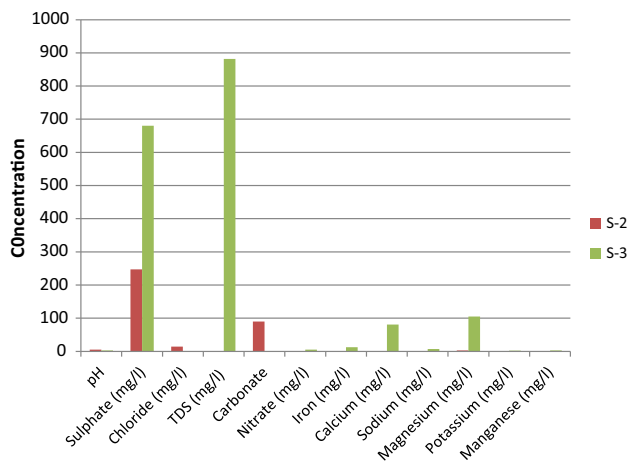
Fig. 11 Distribution of geochemical species in Samples S-2 and S-3 collected from the same stream but at different locations

Samples 2 and 3 (Table 1) were collected from the same stream but from different locations. In between the two sample locations lies the Okpara Coal Mine/mine spoils dump. Sample 2 was collected ‘upstream’ while Sample 3 was collected ‘downstream’ after and beyond the mine and dump site over which the stream flowed and had contact. The effect of the coal mine and dump site on the hydro-geochemistry and water quality of surface water resource is very striking and evident in the contrasting chemistry of these water samples of the same stream but collected from different locations (Fig. 11). While Sample 2 is of a relatively better quality except for the slightly low pH value of 5.04, Sample 3 is of very poor quality with very low pH value of 2.8 (high acidity), high total dissolved solids TDS of 882 mg/l, and high iron and manganese values of 12.62 and 2.82 mg/l, respectively, which are outside the WHO permissible limits. Calcium and magnesium values analysed from Sample 3, though below WHO limits are significantly high (81 and 105 mg/l, respectively) when compared against values obtained from Sample 2.
